Vehicle-activated signs – a large scale evaluation

Prepared for Road Safety Division, Department for Transport

M A Winnett and A H Wheeler

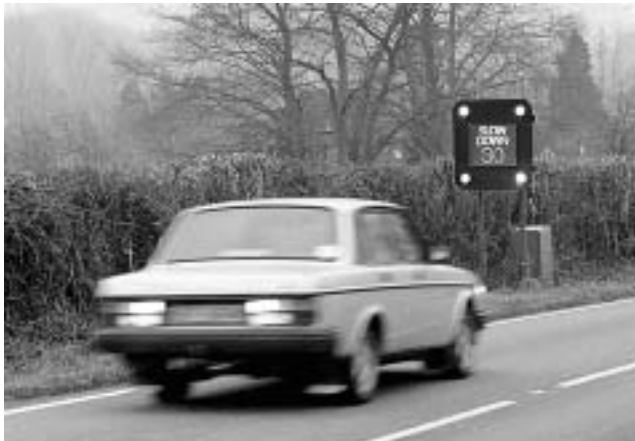
Plate 2 Speed reduction sign

The sign advising drivers to 'SLOW DOWN' (Plate 2) had a message formed by a number of pinpoints of light individually supplied through fibre-optic cables. The vehicle speed was measured from inductive loops buried in the carriageway. The original 'SLOW DOWN PLEASE' message was later amended to 'SLOW DOWN 30'.

The close following sign was trialled on the A332 at Ascot, Berkshire (Helliar-Symons, 1983) and the speed limit speed warning signs were trialled in Hampshire on the A32 (now B3349) at West Meon and Droxford, where conventional accident countermeasures had not been entirely successful (Helliar-Symons *et al.*, 1984).

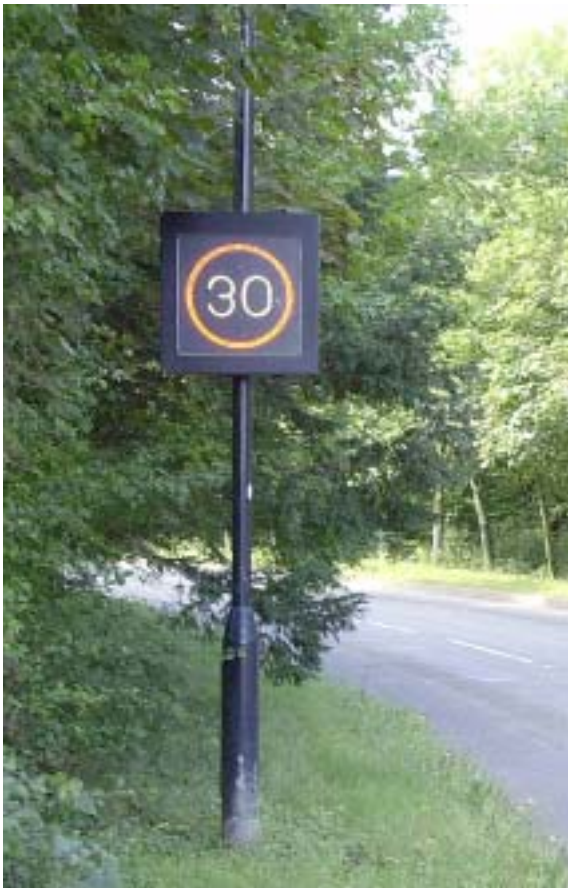
Plate 5 30 roundel without flashers (Brisley, Norfolk)

Vehicle-activated speed roundel signs are not repeater signs since they will only operate for drivers exceeding the speed limit. Consequently they do not display to all traffic. Their purpose is to reinforce the posted speed limit. Speed limit roundels were installed between 20 metres and 50 metres beyond the first sign indicating the change in the speed limit. For example, on a section with a 30mph limit, the vehicle-activated sign would be situated within this speed limit, 20-50 metres downstream from the speed limit terminal sign.

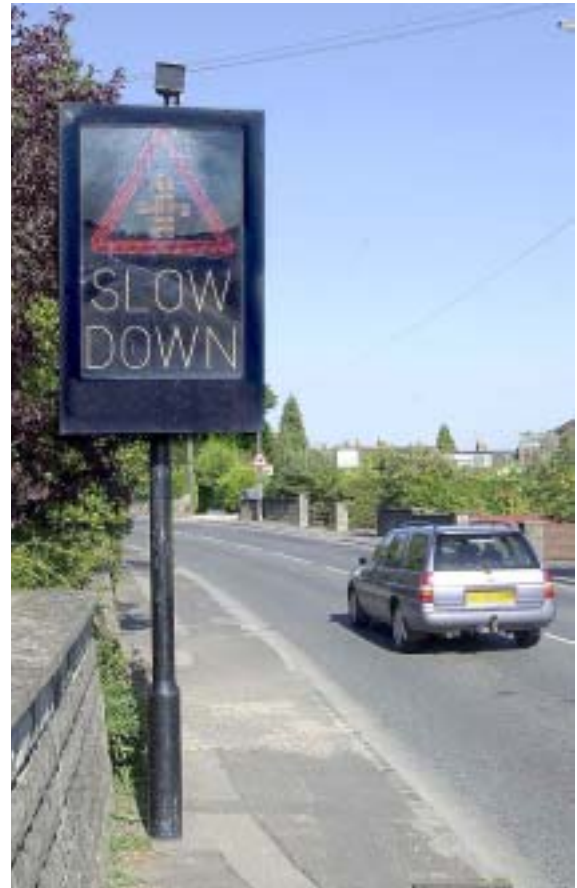
Plate 7 Junction warning sign (Wootton Bassett, Wiltshire)

The junction signs were developed to tackle the problem of speeds that were unsuitable for the conditions. Many collisions at junctions are caused by driver error when entering a junction from the minor arm and failing to estimate the speed of approaching vehicles on the major arm. Approaching vehicles on the major arm of the junction (priority arm) may not have a clear view of the junction and may not be aware of emerging vehicles until it is too late to take appropriate action. The junction signs have been developed to counter this problem and tackle the inappropriate approach speeds of vehicles.

It is not always possible to reduce speed limits over a short distance where there is a hazard related to speed and this highlights the fact that speed limits are often inflexible. The junction warning signs are designed to deal with this particular problem. These signs have been located between 100 metres and 150 metres from the centre of the junction.

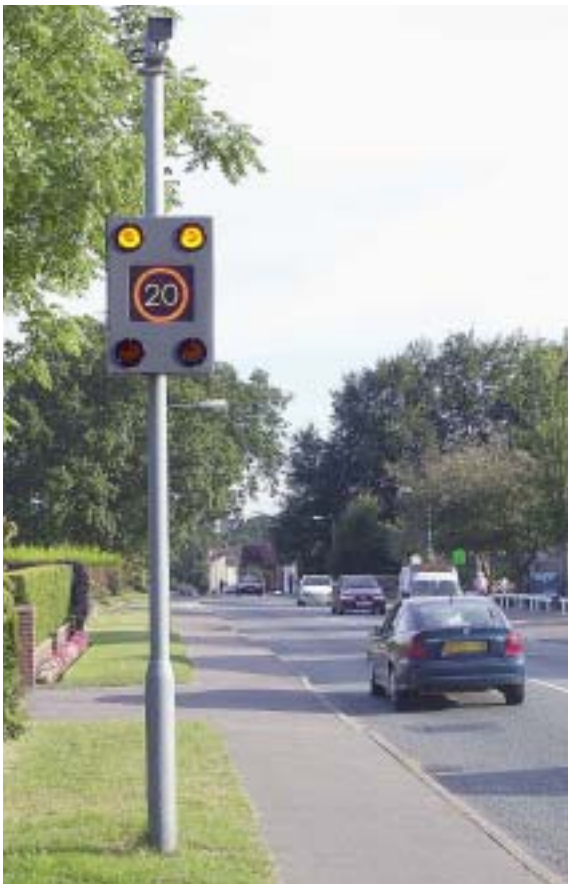
Plate 6 20 roundel with amber flashers (Horsford, Norfolk)

The signs in Kent and some in Norfolk were complemented by pairs of flashing amber lights that are triggered at the same time as the sign itself.

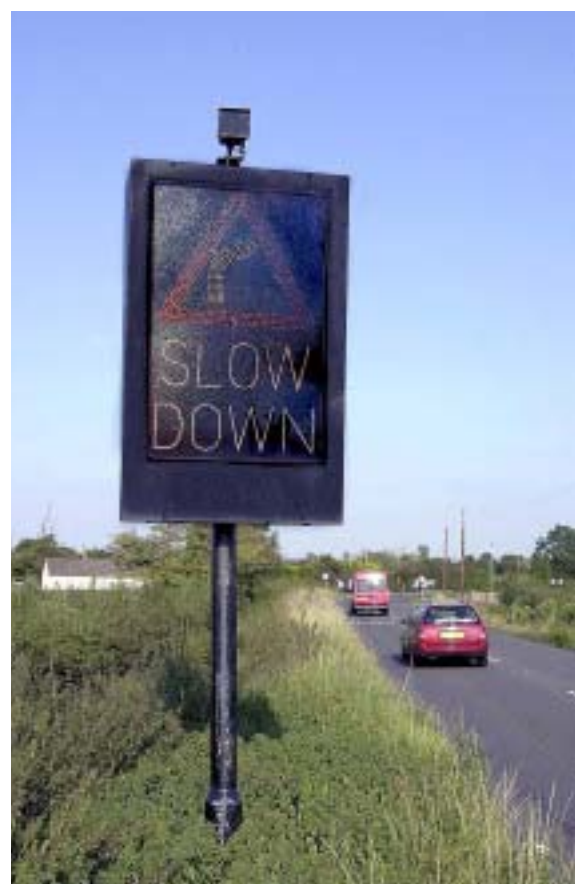
Plate 8 Bend warning sign (Sells Green, Wiltshire)

A major contributory factor reported by the police in bend accidents is excessive speed for the conditions. The bend signs were developed to deal with the problem of accidents involving loss of control due to excessive speed on the approach to bends. Many of these accidents are also associated with wet roads where tyre adhesion is reduced. This highlights the problem that drivers do not always take into account the prevailing conditions and adapt their behaviour accordingly. It is possible that since many of these accidents occur on minor roads, with a high proportion of local traffic, over-familiarity with the route and lack of concentration may be additional contributory factors. The signs give advance warning of the hazard, to reinforce the potential risk associated with the bend. These signs were located between 50 and 100 metres in advance of the apex of the bend.
